Tena Peterson
DBRVI Inspection 000021

2002 Trail Lite Class A

6/7/17

DBRVI Inspection 000021

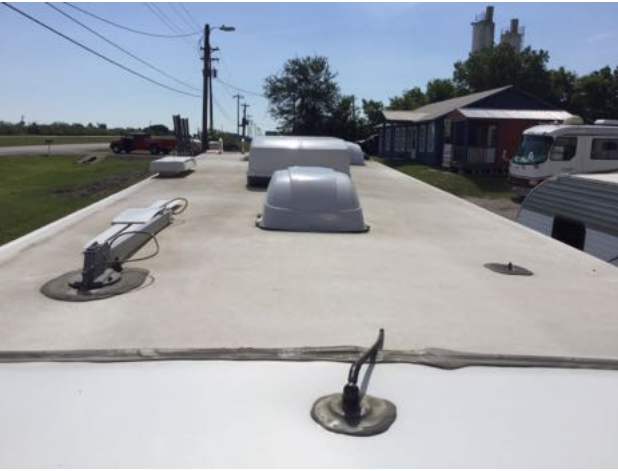
Appendix 1

<p style="text-align: center;">Appendix 1</p>		
Joints & Seals		
Roof Front End Condition:	Fair	Sealant along front cap seam exhibits signs of decay, cracking.
<div style="display: flex; justify-content: space-around; align-items: flex-end;"> <div style="text-align: center;">

1. Replace sealant on roof seams.

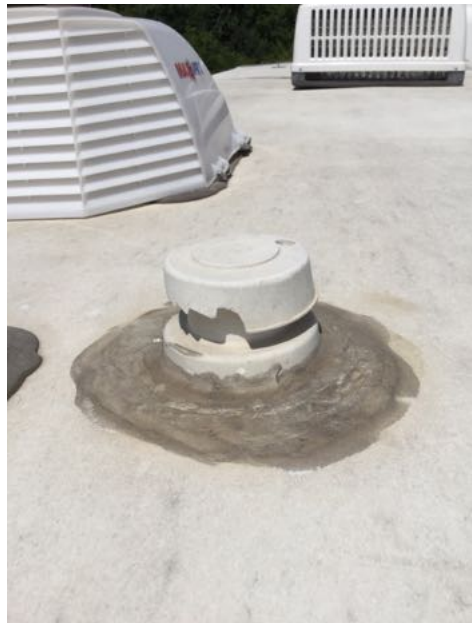
Appendix 12

<p data-bbox="165 517 288 544">Appendix 11</p>		
Plumbing Vents Count:	1	
Plumbing Vents Condition:	Fair	Cracked plumbing vent cover.

2. Replace plumbing vent cover.

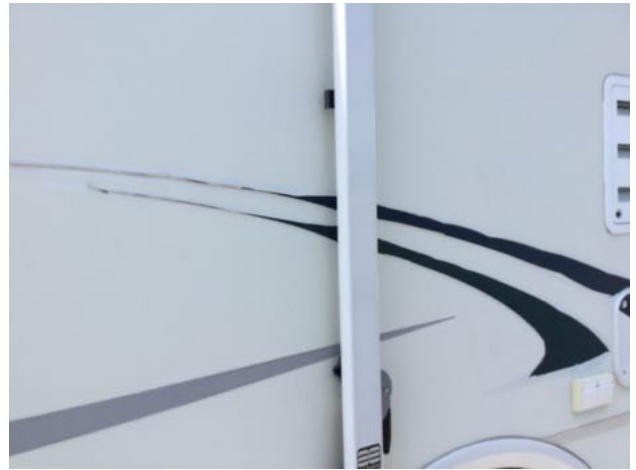
Appendix 26

Question	Response	Details
Curb Side Type & Condition		
Curb Side Type:	Gelcoat Fiberglass	
Condition:	Acceptable	
Wall Surface		
Wall Surface Type:	Paint with Decals, Paint with Logos	
Condition:	Fair	Decals shrinking.
<div style="display: flex; justify-content: space-around; align-items: center;"> <div style="text-align: center;">

8. Replace decals/ logos.

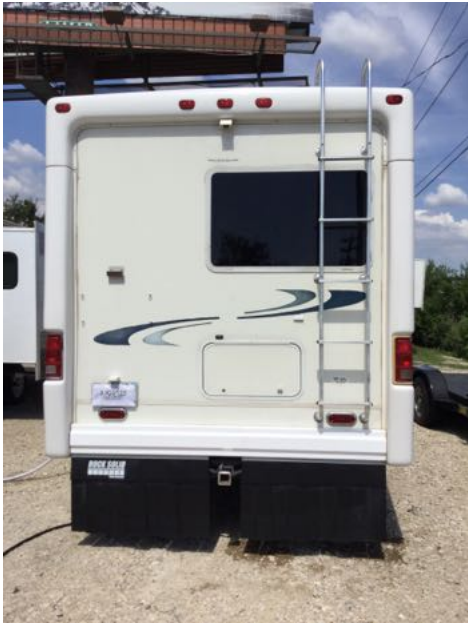
Appendix 41

<p>Appendix 41</p>		
Wall Surface		
Wall Surface Type:	Paint with Decals, Paint with Logos	
Condition:	Fair	Decals & logos fading, shrinking.

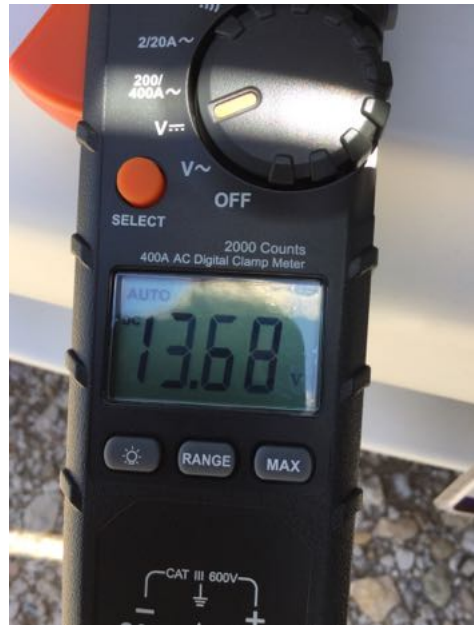
Appendix 72

Question	Response	Details
Battery 1		
Battery Type:	Deep Cycle	
Protective Box?	<input checked="" type="checkbox"/>	
Terminal Posts Condition:	Fair	Rusty battery connection.
