Tena Peterson
DBRVI Inspection 000021

2002 Trail Lite Class A

6/7/17

DBRVI Inspection 000021

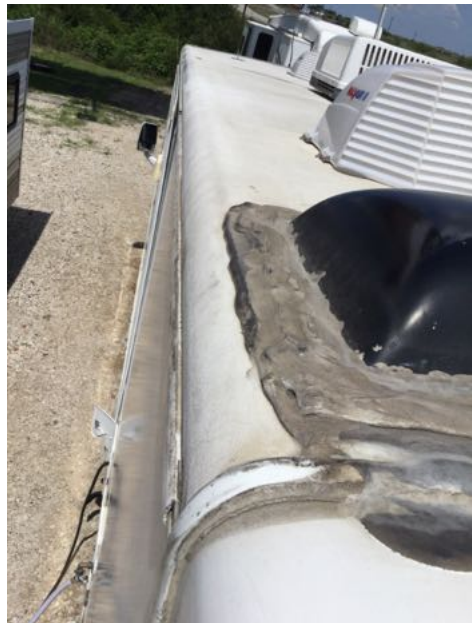
Appendix 7

<p data-bbox="172 517 284 544">Appendix 7</p>		
Roof Street Side Condition:	Acceptable

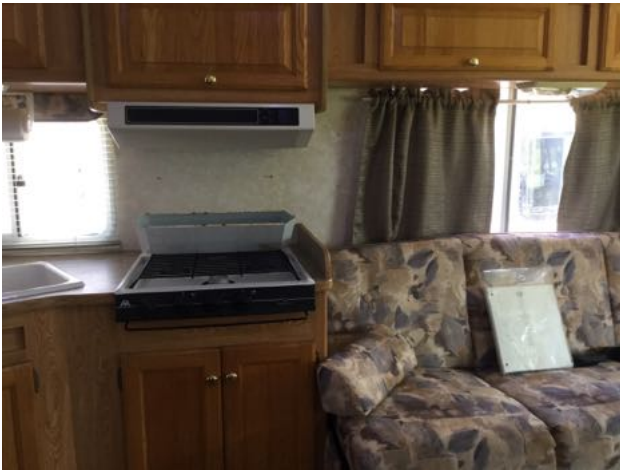
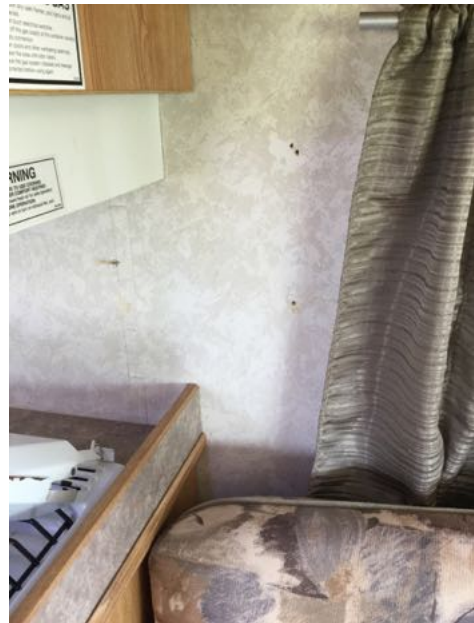
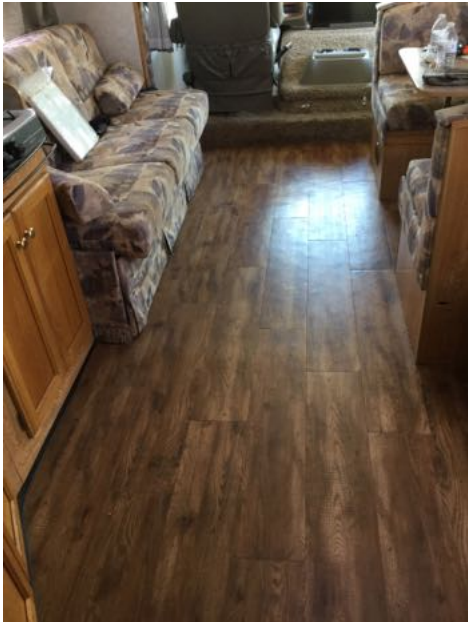
<p>Appendix 105</p>		
Discoloration, Damage or Stain?	No	
Operation of Roof Vents:	Acceptable	
Light Switch and Fixtures:	Acceptable	
Ceiling Fan:		
Walls Condition and Appearance		
General Condition of Walls:	Fair

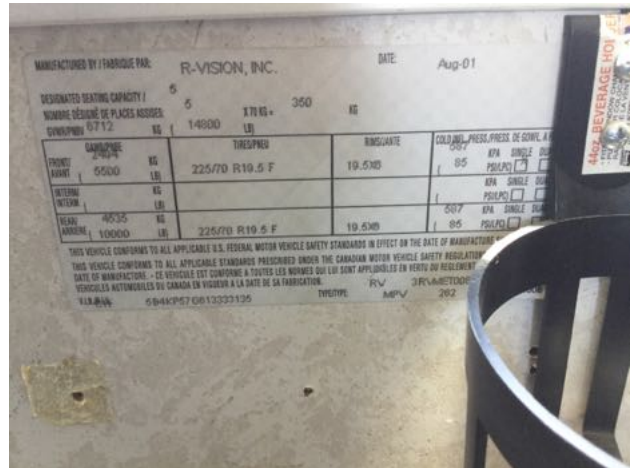
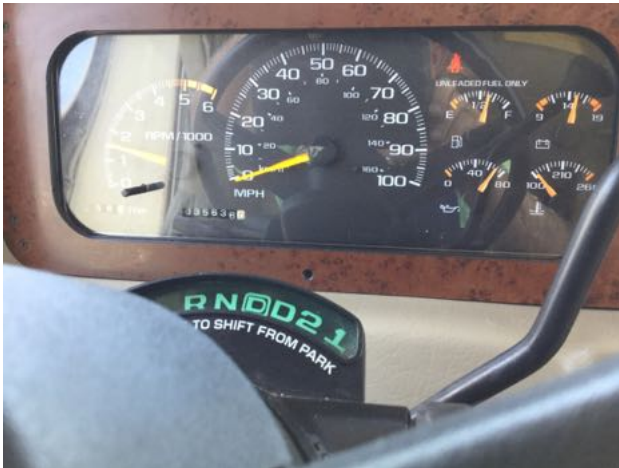
Appendix 117 Appendix 118		
Vehicle Data Plate		
GVWR:	14800	
OCCC:		
Cockpit / Navigation Area		
Dash Control Gauges Condition:	Good	The headlight switch is inoperative- loose in the dashboard. Could not make the lights come on.
