2013 Keystone Montana Mountaineer 345DQ

Don Baker RV Inspections LLC - Exterior Conducted on 18th Feb, 2019 By Donald Baker

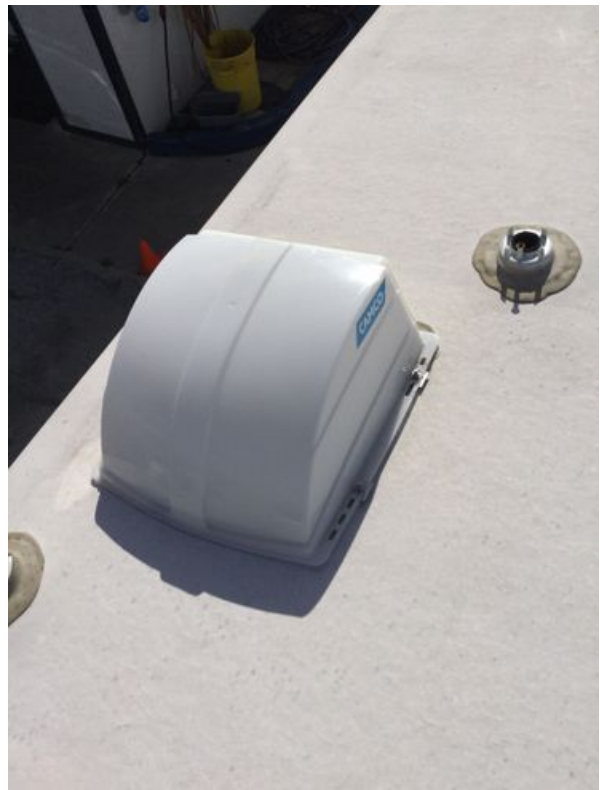
Photo 50	Photo 51
Roof Vent Condition	<input checked="" type="radio"/> Acceptable
Roof Vent Sealant Condition	<input checked="" type="radio"/> Acceptable

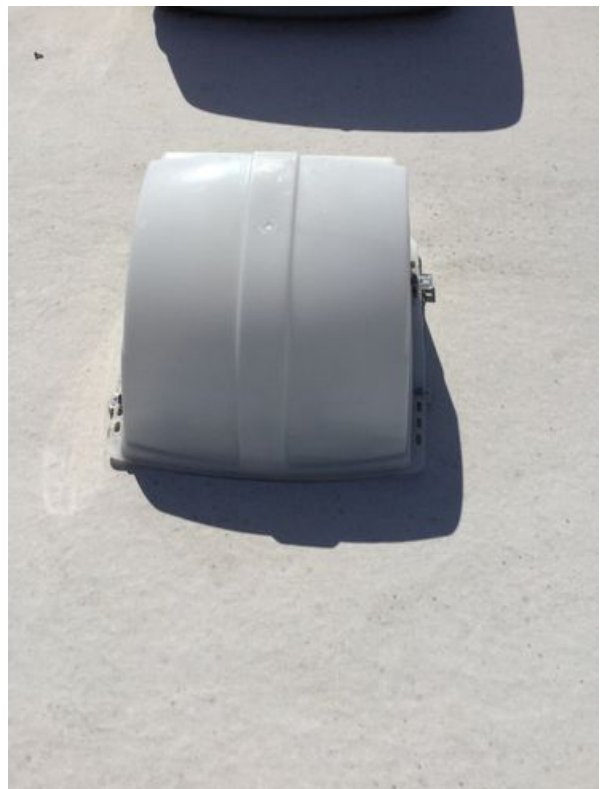
Photo 52	Photo 53
Roof Vent Condition	<input checked="" type="radio"/> Acceptable
Roof Vent Sealant Condition	<input checked="" type="radio"/> Acceptable

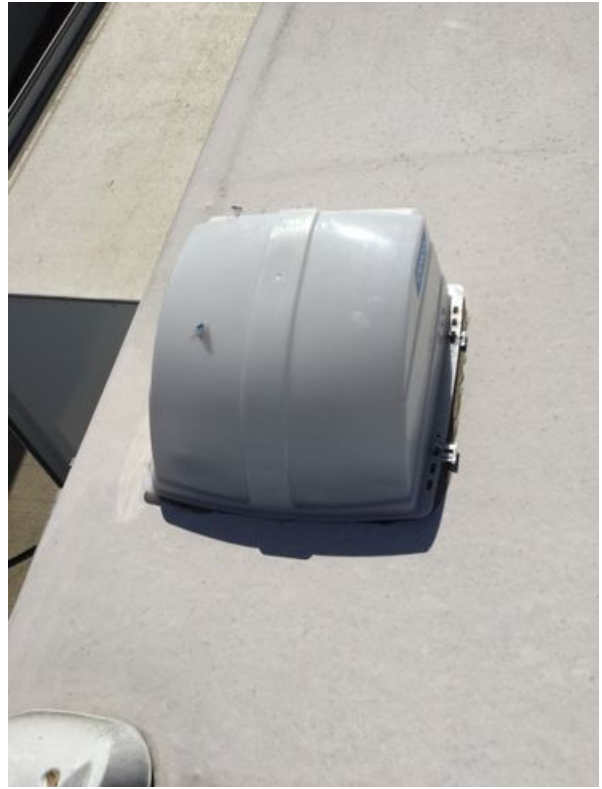
Photo 54	Photo 55
Roof Vent Sealant Condition	Acceptable

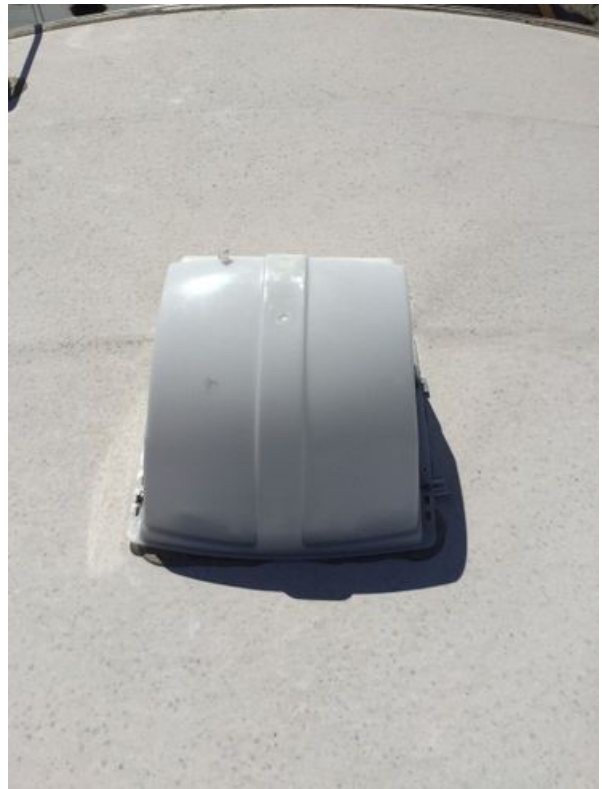
Photo 56	Photo 57
Roof Vent Sealant Condition	Acceptable

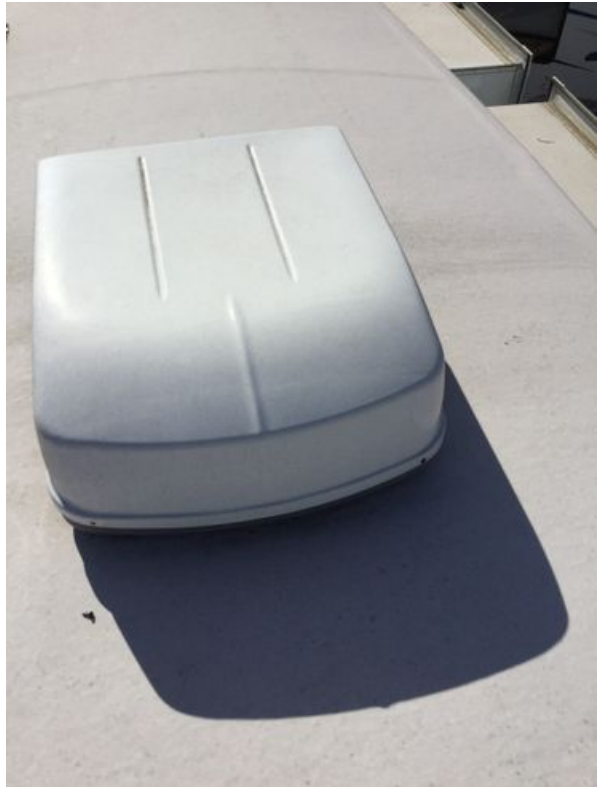
Photo 79

</div> <p>Photo 79</p>	
Air Conditioner Exterior Coils Condition:	Acceptable

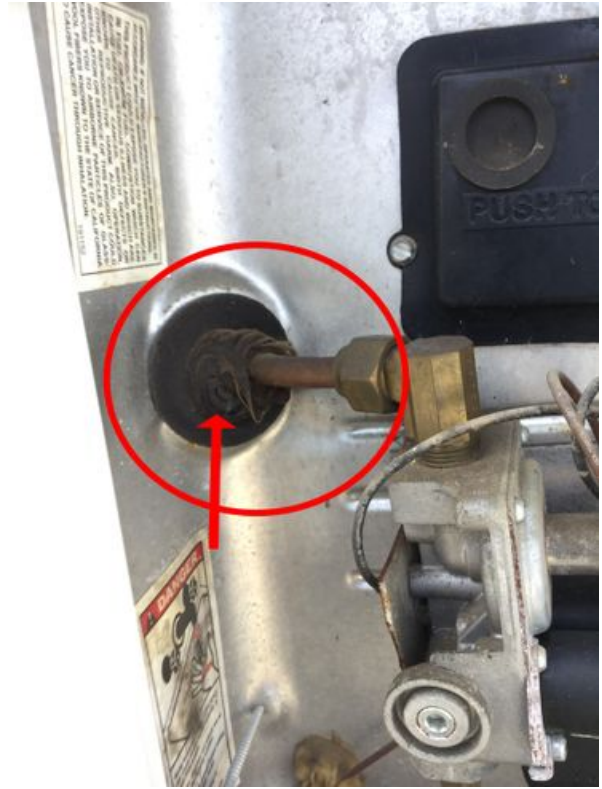
Photo 115	
Reason: Very rusty.
